| NR, CADASTRAL 75989 | | |

Disfunctionalitati

Prioritati:

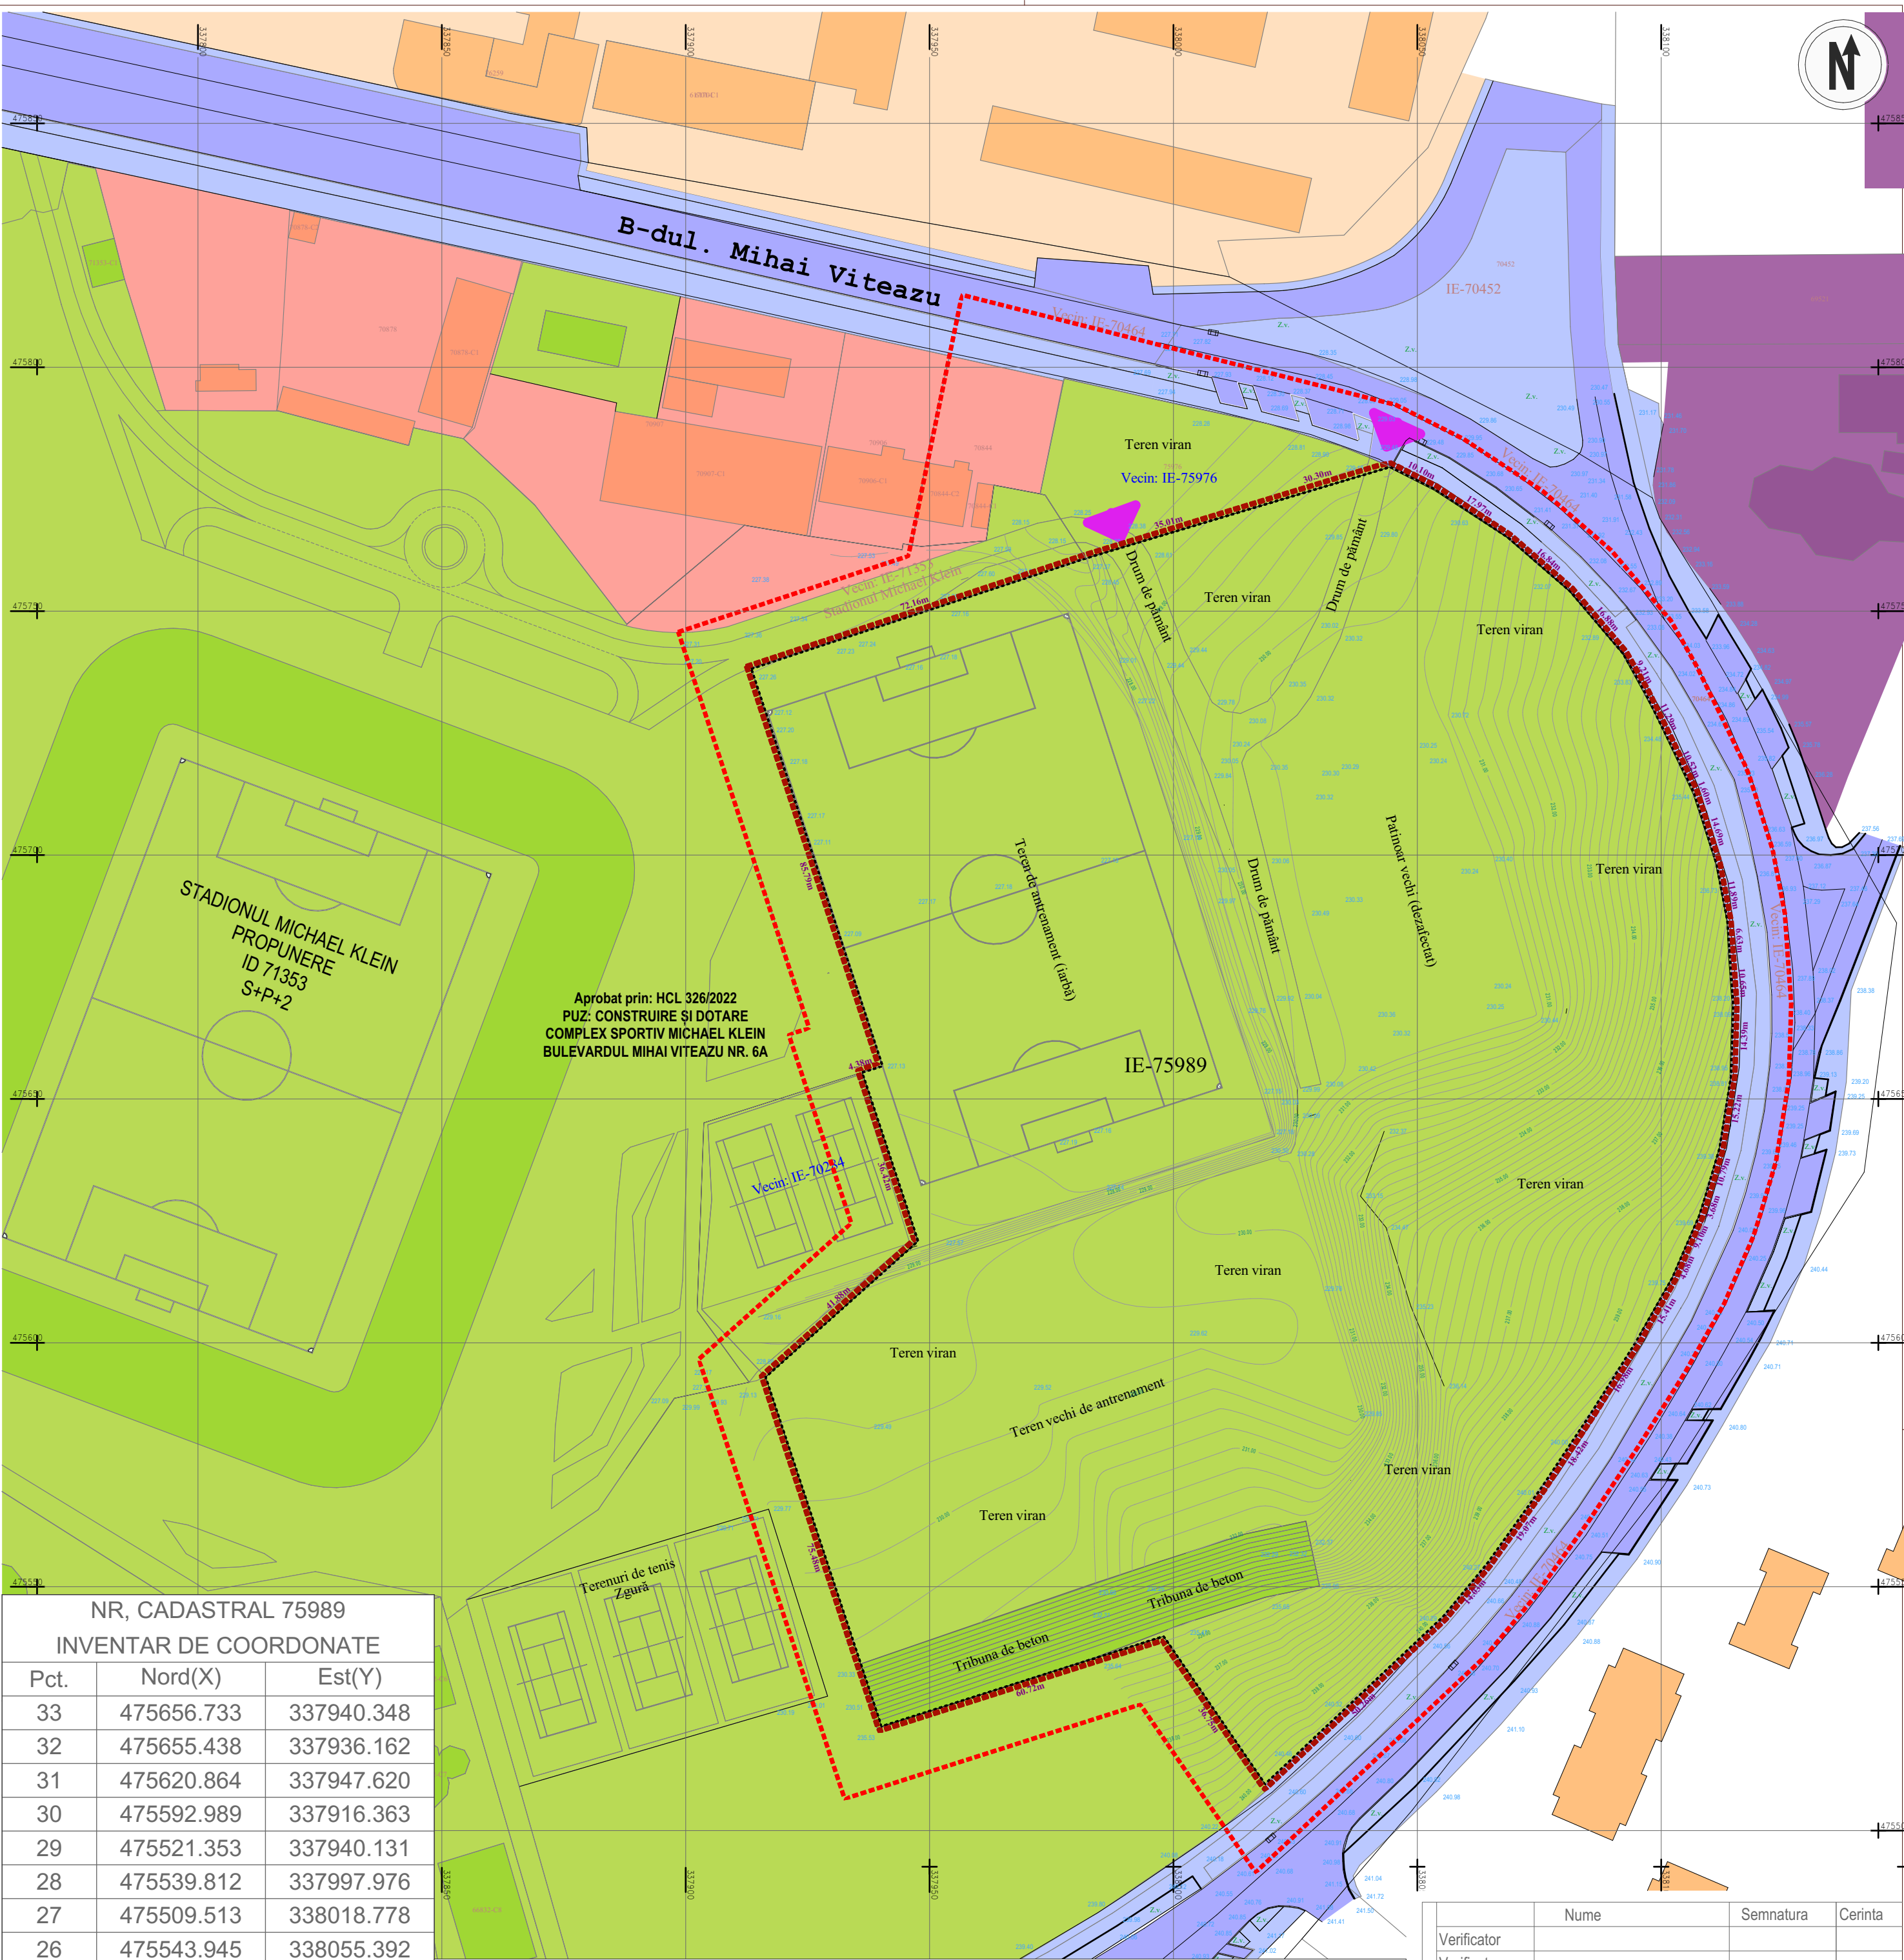
- lipsa spatiilor de parcare
- nu exista o delimitare functionala a terenurilor
- nu este asigurata preluarea apelor pluviale din zona studiata
- lipsa zonelor verzi plantate

- se vor propune spatii de parcare conform HGR 525/1996, art. 5.8.1, un loc de parcare pentru 20 de persoane
- se vor propune 3 zone functionale, una pentru constructii, una pentru zonele verzi si una pentru circulatii
- apele pluviale se vor directiona spre zonele verzi, considerate zone de reinfiltrare a apei in sol
